# SEISMIC EVALUATION REPORT

# Seismic Assessment for Drakes Crossing Main Fire Station

19364 Powers Creek Loop Rd. NE, Silverton, OR 97381

January 10, 2025 24021.00

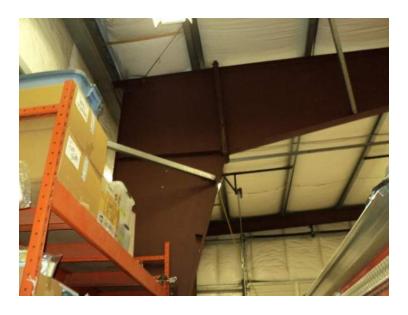
Image 6: Existing Steel Moment Connection

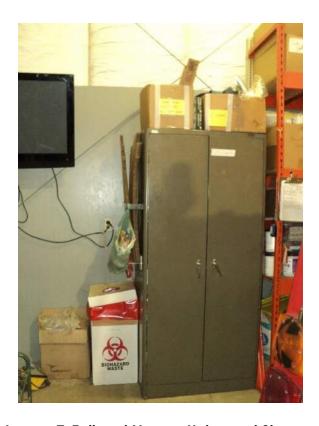
Image 7: Tall and Narrow Unbraced Storage
